Lake Terrace Cemetery Conservation Management Plan

Prepared by Fifth Creek Studio for the City of Mount Gambier

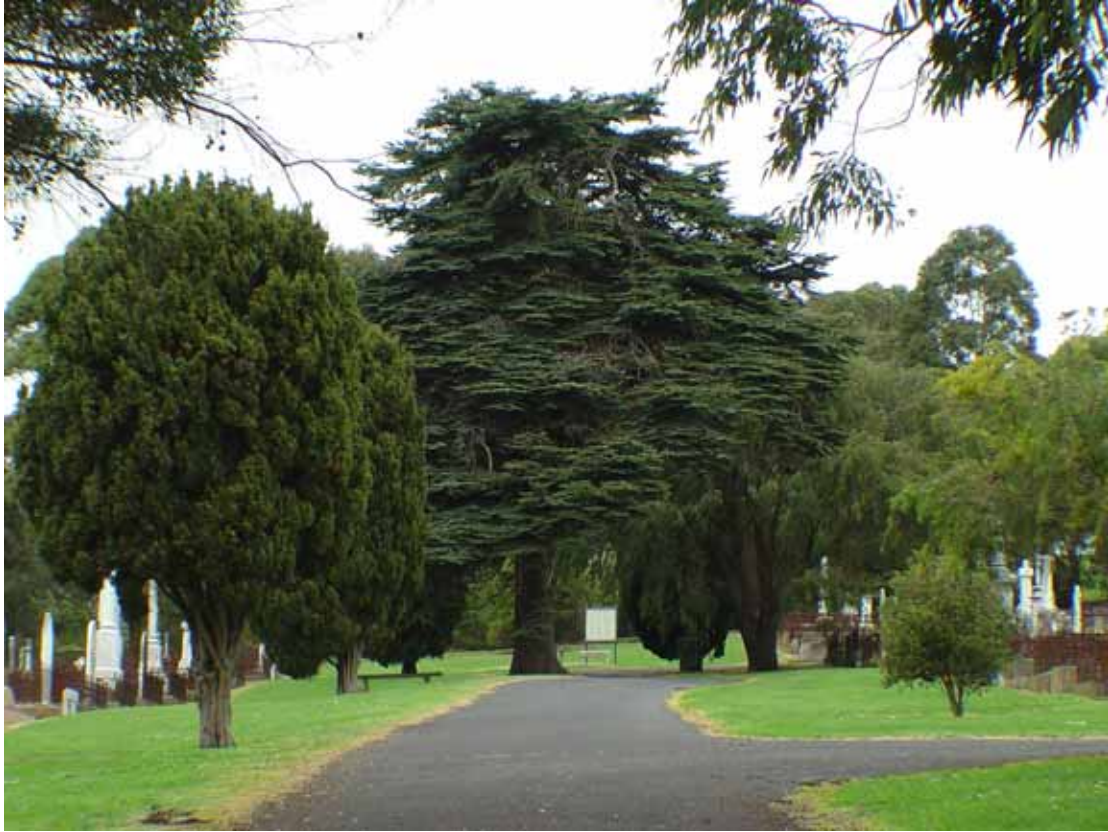
Lebanon Cedar at top of main drive, dating from 1880s and mentioned in 1939 report as a tree of significant value

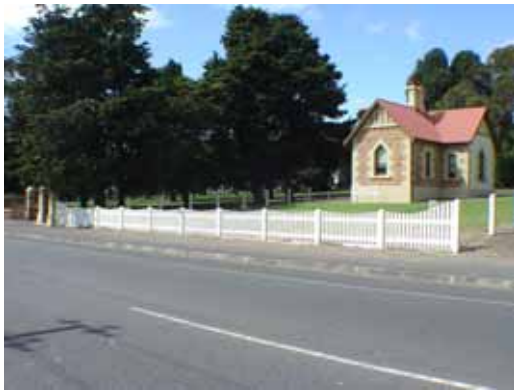
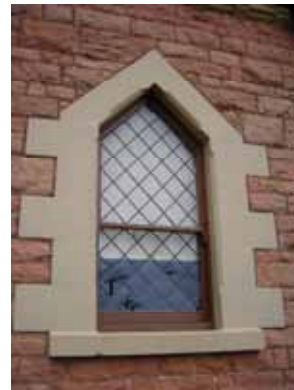
Sexton’s Cottage and reconstructed picket fence *Architectural detail*

In May 1986 it was reported that the northern boundary fence was to be ‘removed and replaced with a planter strip of trees and shrubs’, as the ‘boundary fence had been a problem for several years’. This ‘visual barrier’ was to be from 2 to 5 metres wide, and extend the entire length of the Lake Terrace boundary. The cottage was extensively refurbished by the City of Mount Gambier in 1988, and has been used since by the Mount Gambier Heritage and History Society. In 2006 Council reinstated a picket fence in front of the Sexton’s Cottage at the same time as constructing a new public toilet block near the cottage.

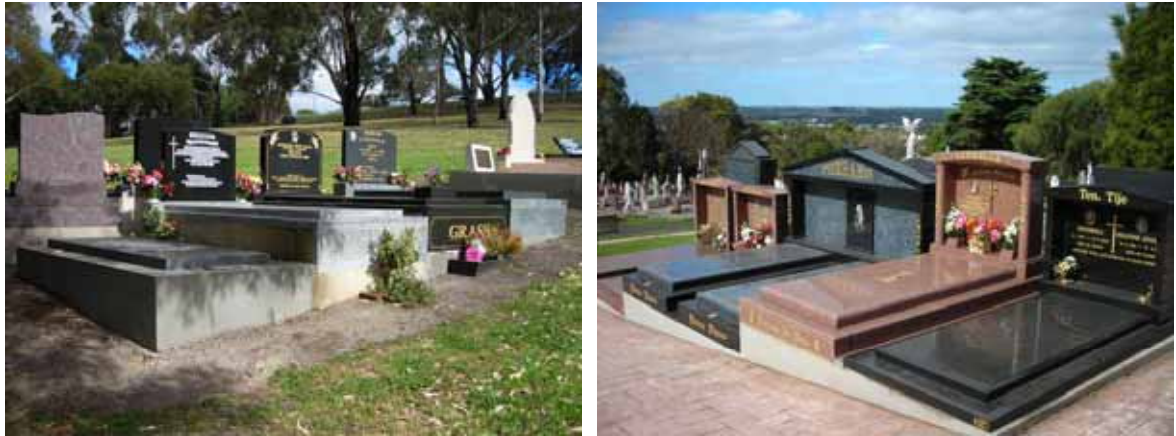
Graves and vaults in the current use sections of the cemetery

Burials at Lake Terrace continue today within some family plots in the historic sections and in new grave sites being provided in Section J and vaults in Section H.

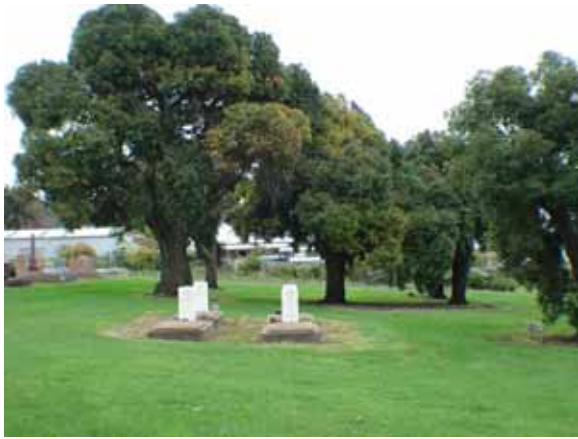
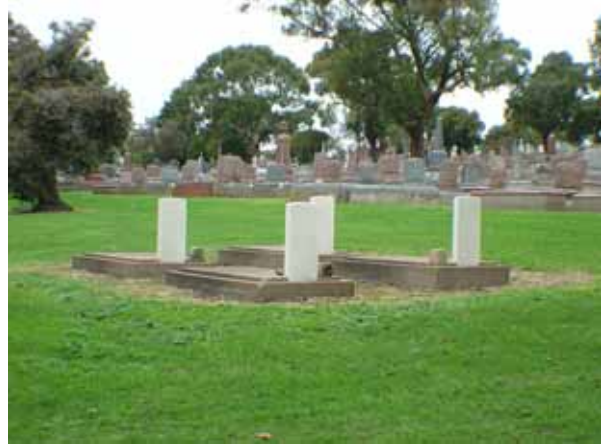
Australian War Graves designated area with four graves

There are currently four graves located here, adjacent to Section M; all of RAAF servicemen who lost their lives while training in the region. The first burial was in May 1943, with the other three in August 1945.

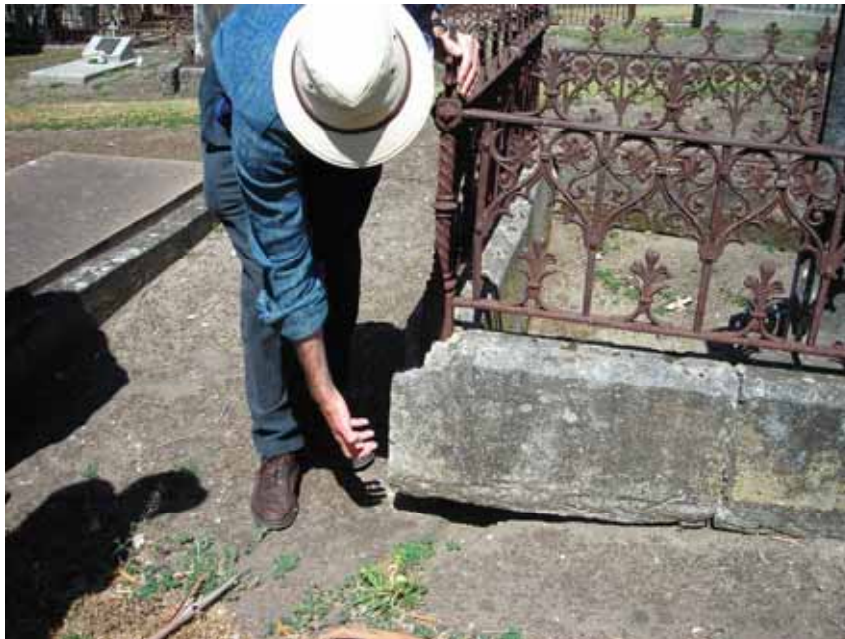
There are drainage issues caused by the side paths within the cemetery cutting across the slope and concentrating the surface runoff into streams. These concentrated streams are flowing along the edge of the foundation stones of historic graves, causing erosion and undermining the foundation stones.

Inadequate drainage undermining foundation stones

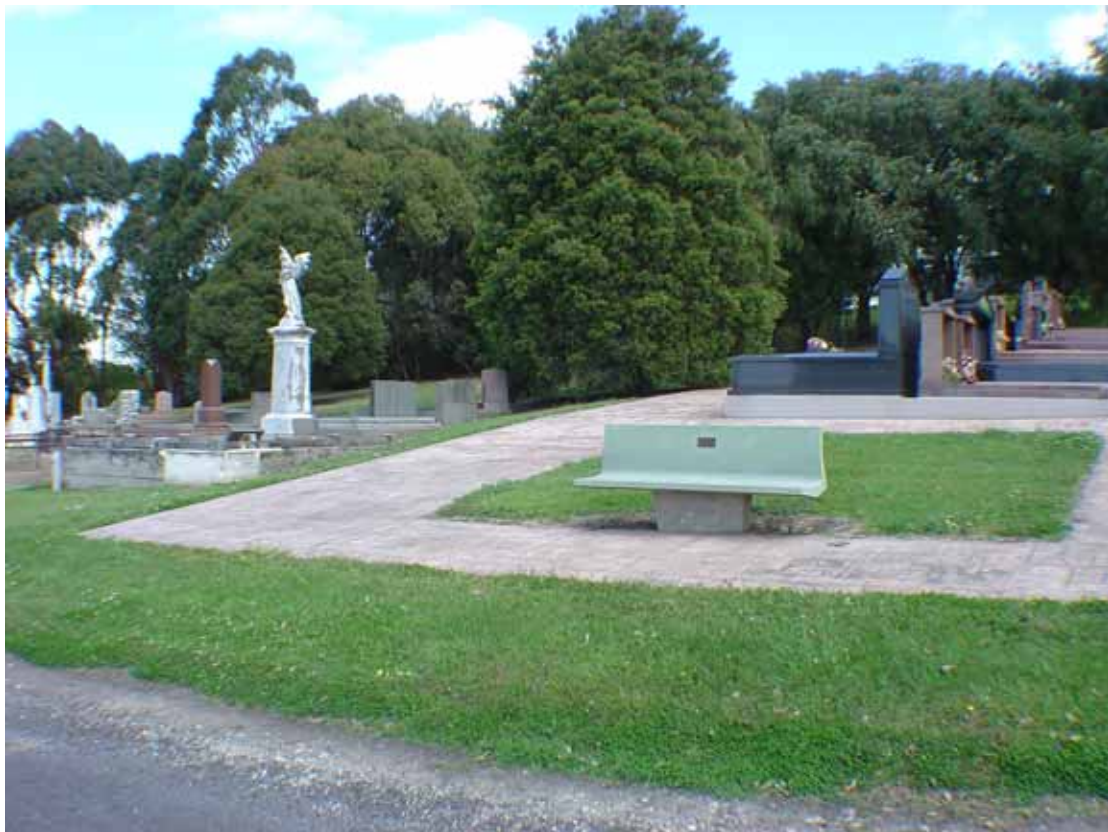
Also there is a visual and physical conflict between the historic sites in Section H and the current use of the neighbouring section. The monument form, materials and paving used in current practice are not compatible with the historic areas. Thus a physical visual barrier must be erected between these two areas because of their close proximity. The current visual conflict is devaluing the historic significance of this part of the cemetery.

Inadequate separation between historic and new sections of the cemetery

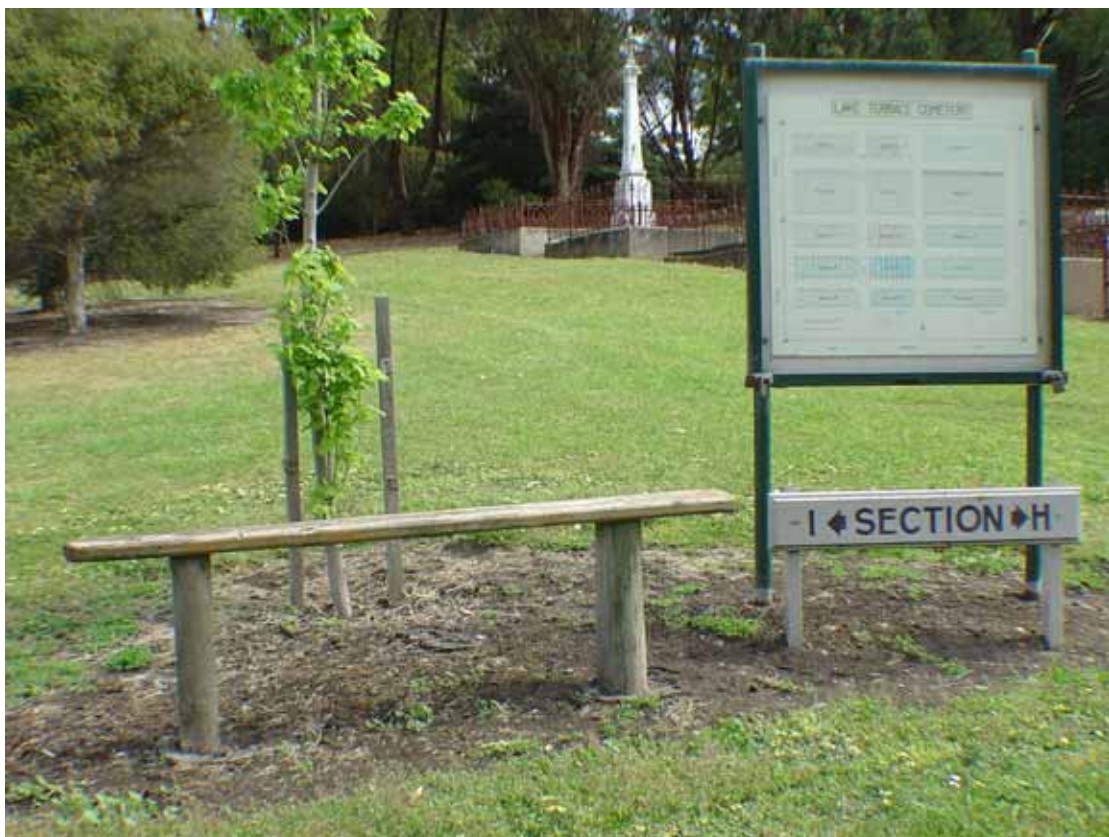
Lake Terrace Cemetery gravesites locational map

The Mount Gambier Heritage and History Society has undertaken a detailed recording project over several years, including cross referencing with cemetery registers held by Council. To date this data has not been computerised or converted into a GIS system, although the need for this has now been discussed by Council and volunteer workers. Progressing this process, to ensure this information is not lost and to improve its accessibility, is one of this conservation management plan's recommendations.

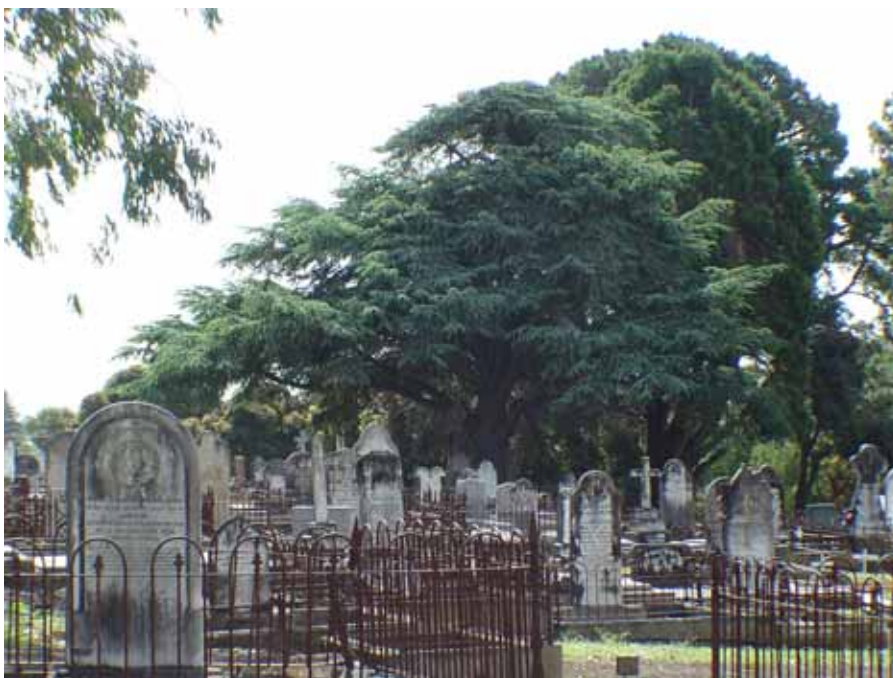
The many cast and wrought iron railings create a special character

4. Lake Terrace Cemetery features many cast and wrought iron grave railings, with most remaining in fair to very good condition, giving the cemetery a distinctive character. There is a preponderance of dolomite and limestone base and kerbing stones, which is particularly significant due to the substantial size and depth of these stones. This indicates the local availability of these materials, and the construction skills displayed in the use of these local stones demonstrates a high level of stone masonry expertise within the community.

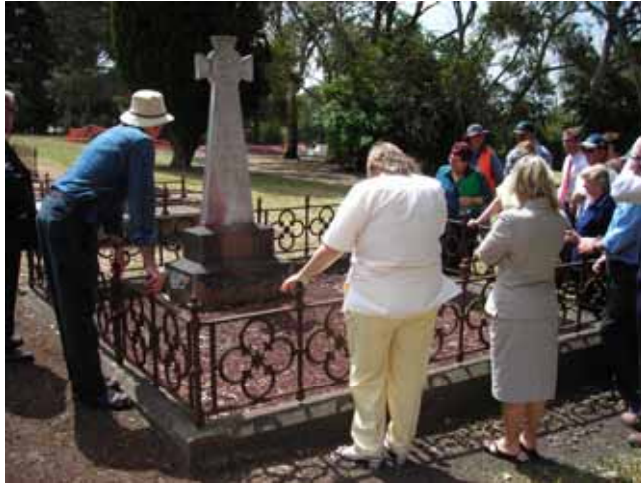
The pink dolomite base of this monument is being discoloured by biological growth, which could be removed using a mild disinfectant, as detailed below.

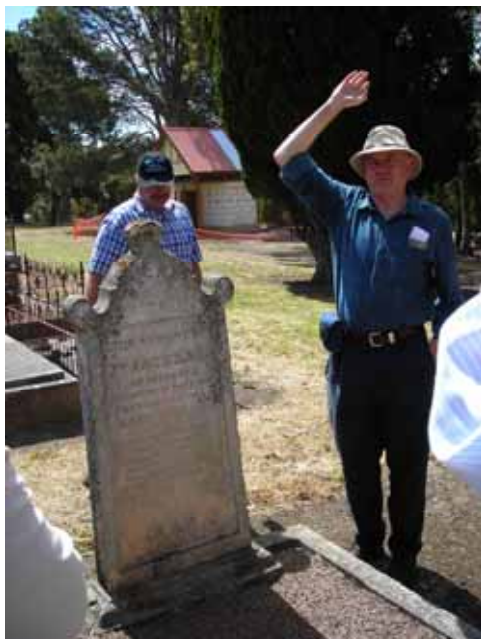
The lichen growth on this stone could be removed from the front, however the growth on the rear of the stone is not creating any damage, so should be left untouched. To remove the biological growth the stone should be thoroughly wet so that water soaks into the stone, keeping the applied chemical on the surface. A disinfectant such as 'Wet and Forget' is then brushed onto the surface and left for 3 to 4 weeks. Then it should be rinsed off and if necessary given a second application. Again this should be rinsed off and then should only need to be reapplied every 4 or 5 years.

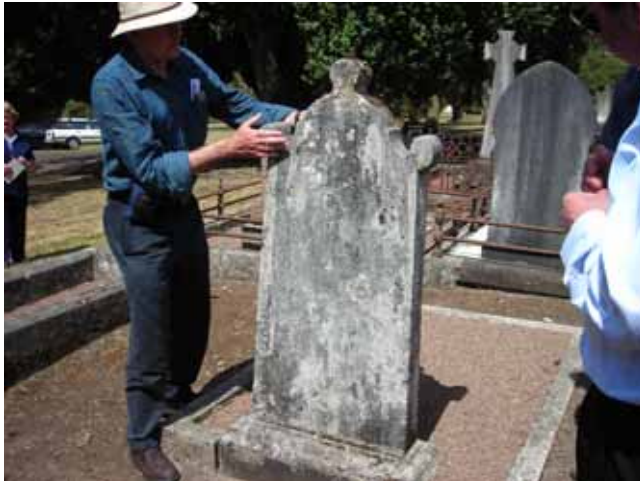
In some cases it may be necessary to remove moulds where they are harbouring a build up of dirt. Although the lichen on the back of this stone can be left, the thick mould growing across the top could be removed by scraping off with a stiff plastic spatula or even a credit card, and a disinfectant solution applied if necessary. Then any dirt residue can be treated separately with mild detergent.

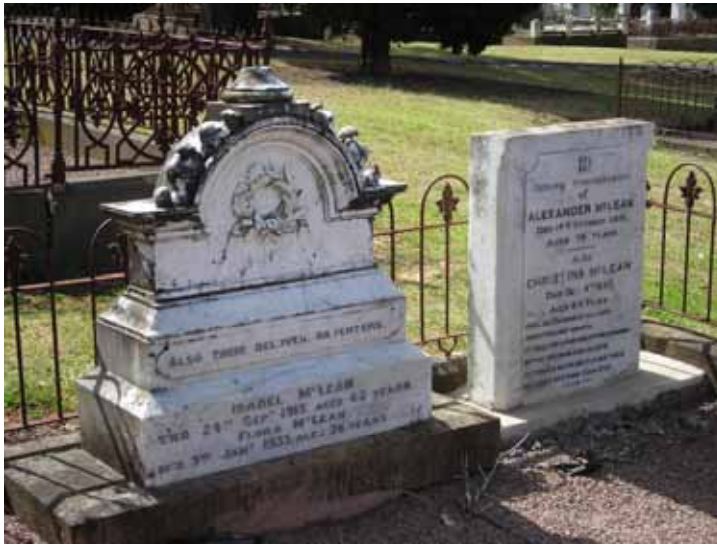
This headstone is an interesting example showing a succession of repairs after the three components became separated. The component on the right of the photo is actually the centre section of the monument, with the top section having been cemented directly onto the bottom section. The middle section has since been set into a new concrete base, making it difficult to re-assemble the monument into its original configuration.

Ideally the three sections should have been re-assembled using traditional lime mortar, allowing them to be separated again if needed. If one of the three sections was to be left out for some reason, it would be more appropriate to stand it up embedded in a tamped down gravel bed, giving flexibility for future repairs, or alternatively it could have been laid down in front of the other sections on a gently sloping bed of gravel or a supporting limestone slab.

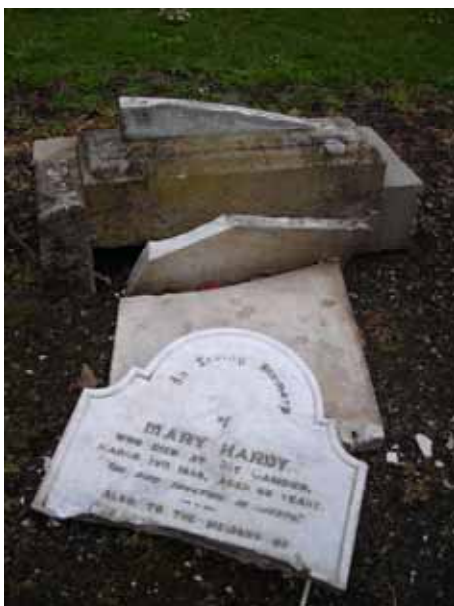
This monument involves base stones that need to be reset onto tamped ground. The broken headstone could be repaired using a modern adhesive, however the repaired stone might not be robust enough for re-setting into the base stones. Instead the repaired stone could be laid in front of the base stones on a sloping bed of gravel or supporting limestone slab.

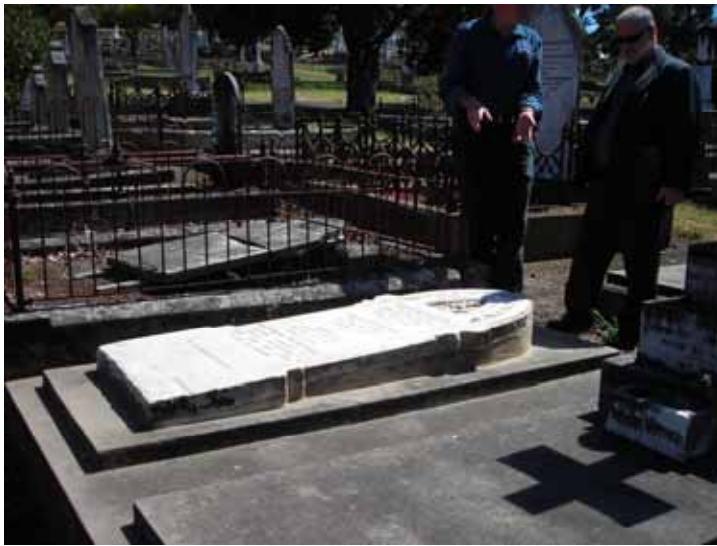
The monument in the mid foreground in this photo has been laid onto a limestone slab and then cement rendered around the sides. It would be preferable to leave the sides open rather than rendered, for moisture to move away from the headstone and to reduce the risk of the stone cracking through incompatible rates of heating and cooling expansion.

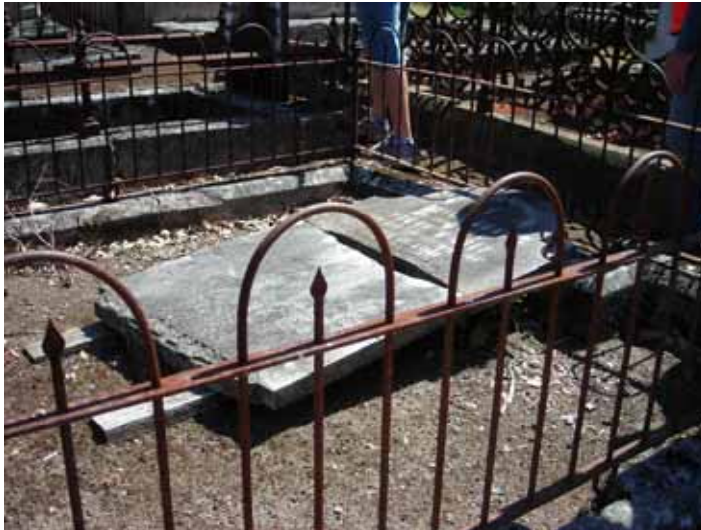
This stone has been laid down on sloping timber supports, which allows air and moisture movement around the stone, but may not support the stone enough to prevent eventual slumping and cracking. It would be preferable to lay the stone on a gently sloping bed of gravel or a limestone slab.

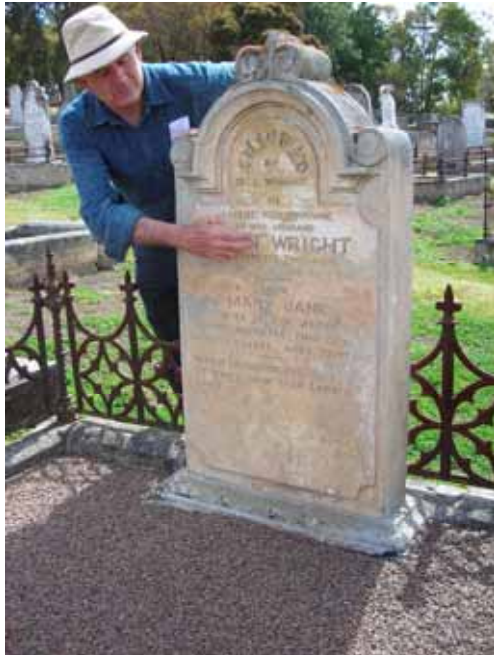
This sandstone monument shows various layers of painted surface, and is best left unpainted, so that its history is revealed. Over-painting would probably conceal the lettering too much and increase the risk of moisture being trapped in the stone.

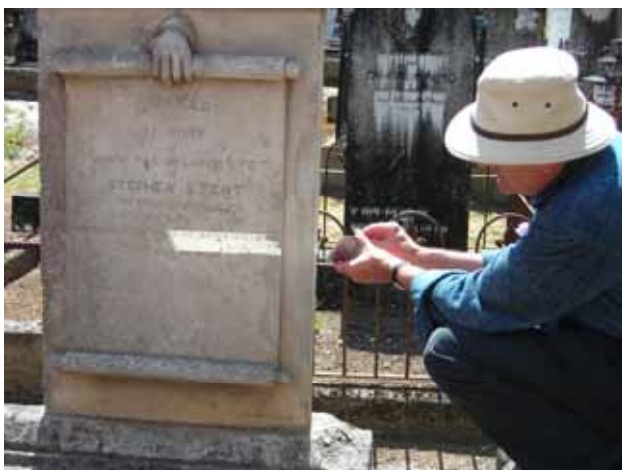
David Young demonstrates the use of a compact mirror to greatly improve the readability of faint lettering on a sandstone monument.

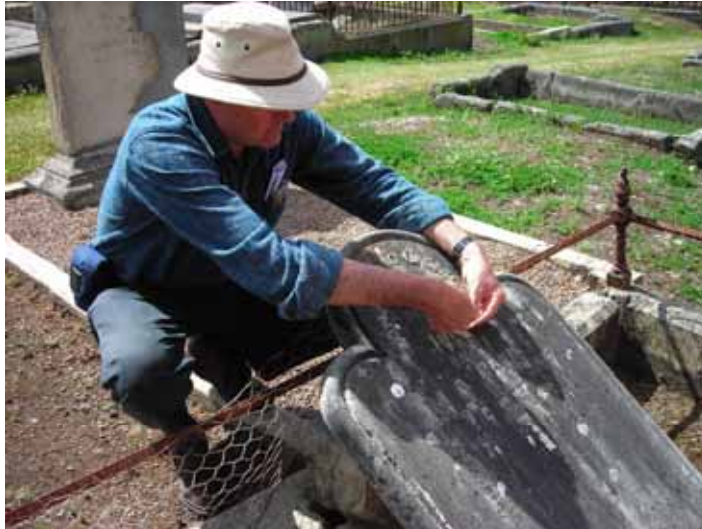
Lead lettering has fallen out of this monument, exacerbated by the steep angle of repose. The remnant gravel of the gravesite should be collected up and sieved to retrieve lead letters lying around the stone. These should be tapped back into place if possible, and the stone laid down at a more shallow angle supported on a bed of gravel or a limestone slab.

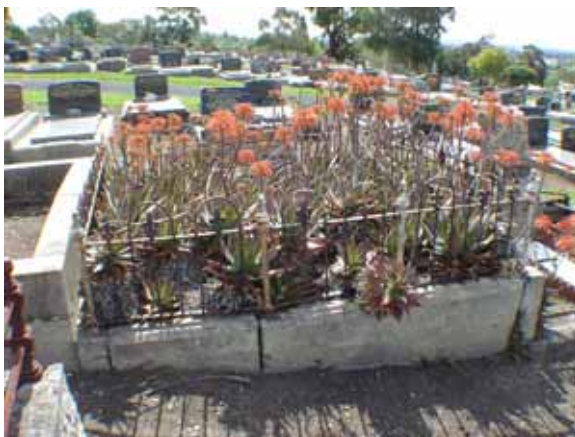
This aggressive succulent has entirely taken over the gravesite where it started, and is spreading to neighbouring graves. It is forcing out the kerbing, which may eventually fall apart and destroy the cast iron railing as well. These plants should be cut back to ground level and the stems painted immediately with an appropriate strong herbicide. This may need to be repeated several times to ensure complete removal of the plants.

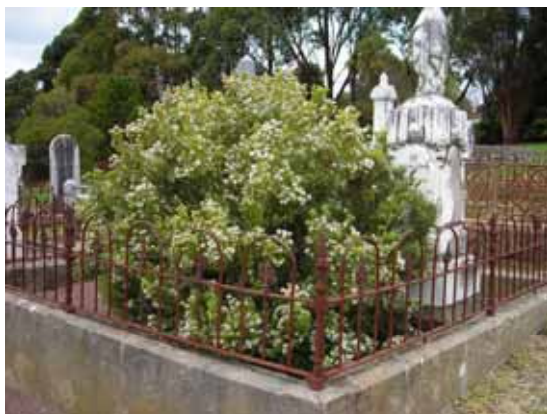
The shrub in this photo is concealing the monument, and will eventually damage the stone kerbing and railing. It should be cut back and its roots carefully dug out as far as possible.

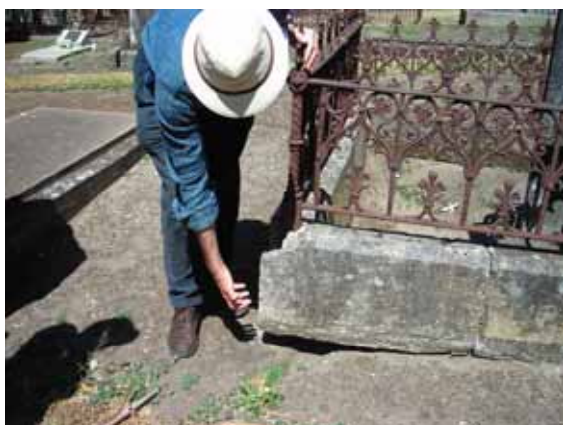
The erosion of soil from under the stone kerbing in this photo is possibly due to rabbits, and is exacerbated by water flowing from inside the grave enclosure. If left unsupported the stone kerbing will eventually break or collapse, also causing damage to the wrought iron railing. This corner should be chocked up with stones to support the kerbing, with these loose stones allowing water to escape and not build up inside the grave enclosure.

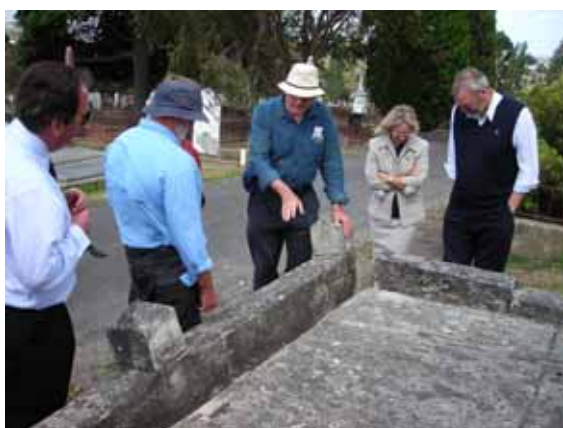
The deep beam dolomite kerbing here is gradually falling away from the grave. Dolomite and limestone kerbing is strong in beam section, however is much weaker if allowed to lie flat. Before these kerbing stone sections fall they should be carefully removed and debris cleaned out so that they can be reset in place. If they are buried deeply enough their considerable weight should be sufficient to hold them in place, with no need for mortars or physical supports.

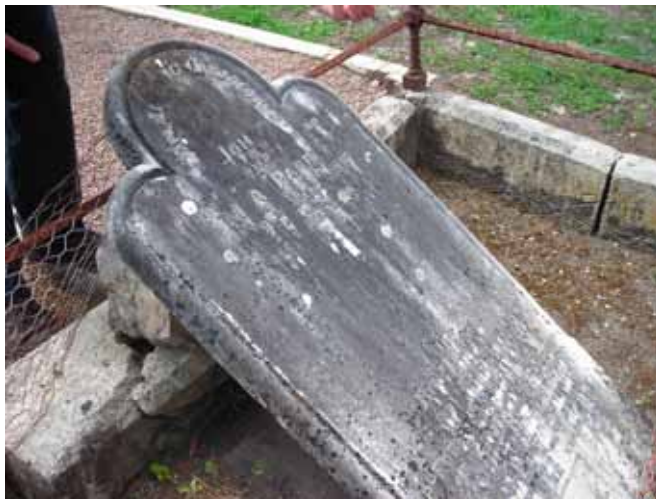
The remnant gravel on the grave floor here should be carefully cleaned up and sieved, then a layer of geotextile spread over the ground surface, and covered by a new layer of gravel or aggregate. A slightly sloping bed of gravel, or alternatively a limestone slab slightly smaller than the headstone, should be installed to support the headstone.

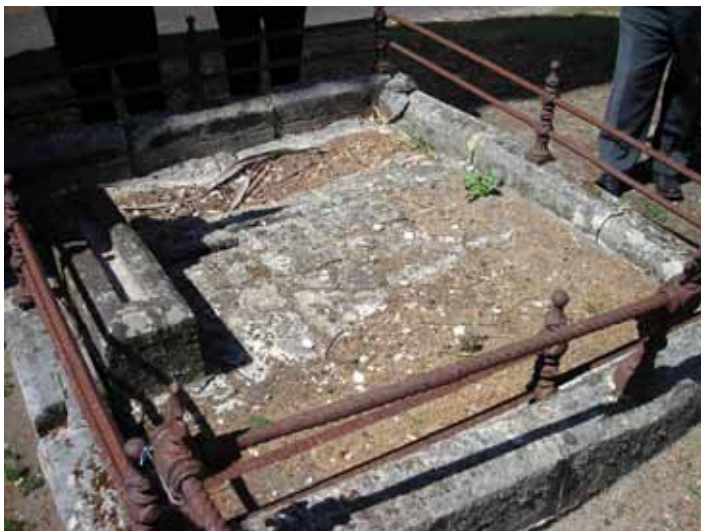
The dirt could be swept up from this grave to expose its concrete floor. This would make the grave look neater and cared for, even though it appears to have lost its headstone.

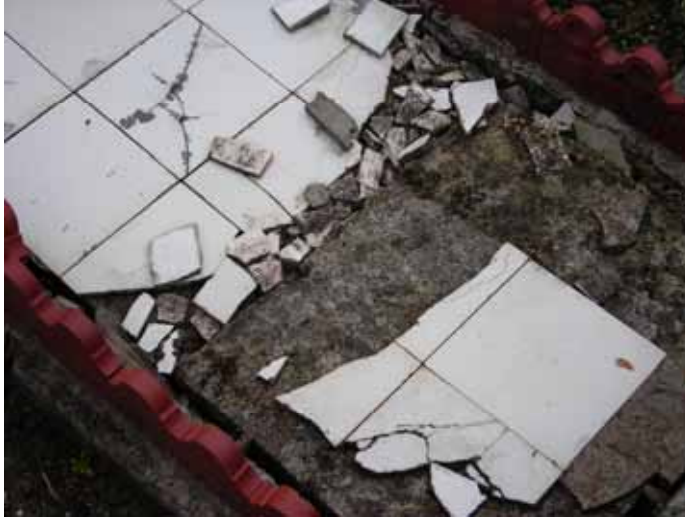
This grave floor has some tiles still intact, but others are loose or broken. Even if the decision is made that the substrate is not smooth enough to attempt re-tiling, a tidy up of the grave would give it a more cared for appearance. Broken and loose tiles should be removed and safely stored.

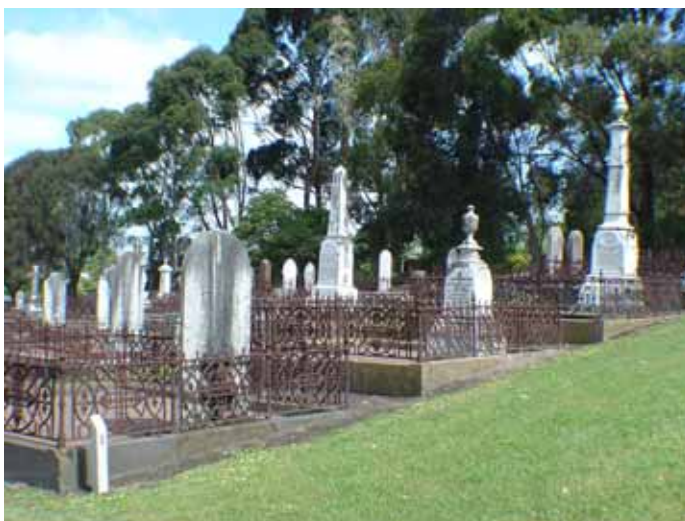
Lake Terrace Cemetery has a wealth of cast iron and wrought iron grave railings and fences which are in need of fish oil preservation. This treatment will extend their lifespan considerably.

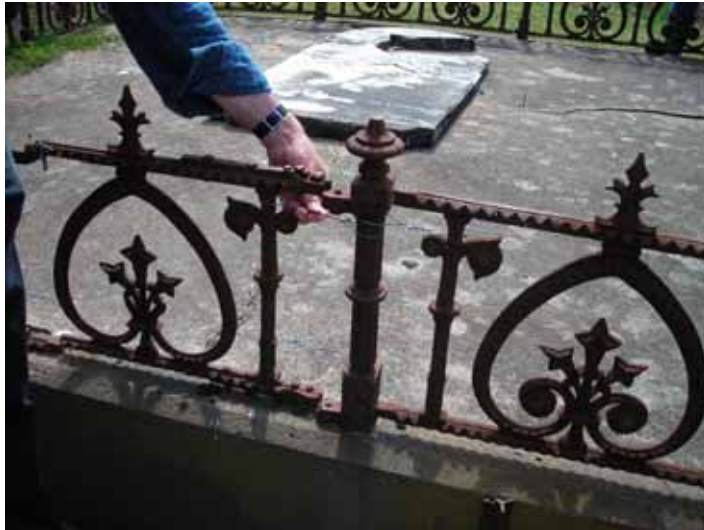
A number of appropriate fencing wire repairs have been made at Lake Terrace Cemetery in the past. All iron fences and railings should be inspected and fencing wire repairs made where needed. The large number of iron railings in this cemetery makes this one of its special characteristics, so it is critical to preserve them.

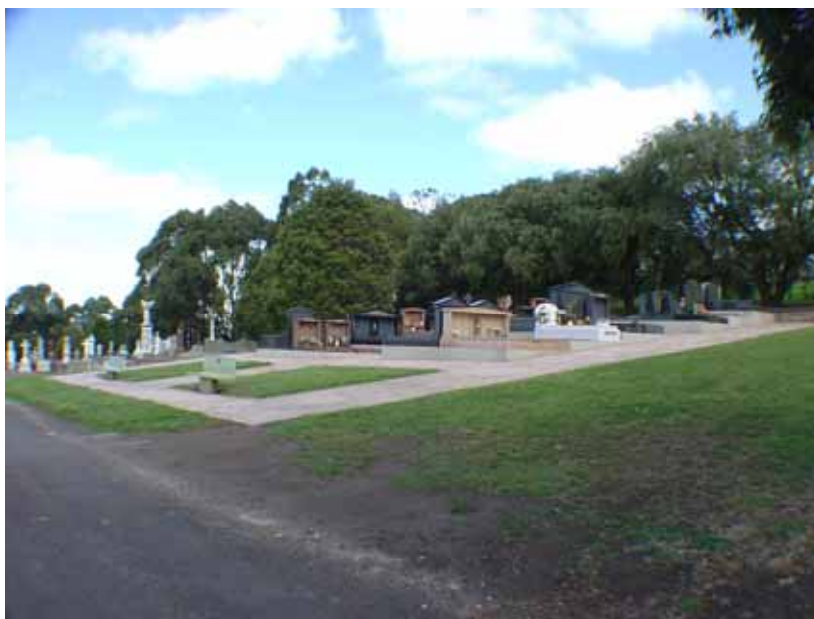
- With the reopening of the cemetery, especially Sections J and H, there appears to be a conflict in approaches to the materials and design of the new grave structures compared with the heritage sites. When these two different styles sit closely together they detract from one another. The proposal is to separate them from each other physically and visually by planting a screen or hedge along the interface line. The vegetation screen should be of a species consistent with the age or period of the heritage grave structures and be densely planted to create a green soft backdrop to both sections.

Heritage sections and new sections need physical and visual separation

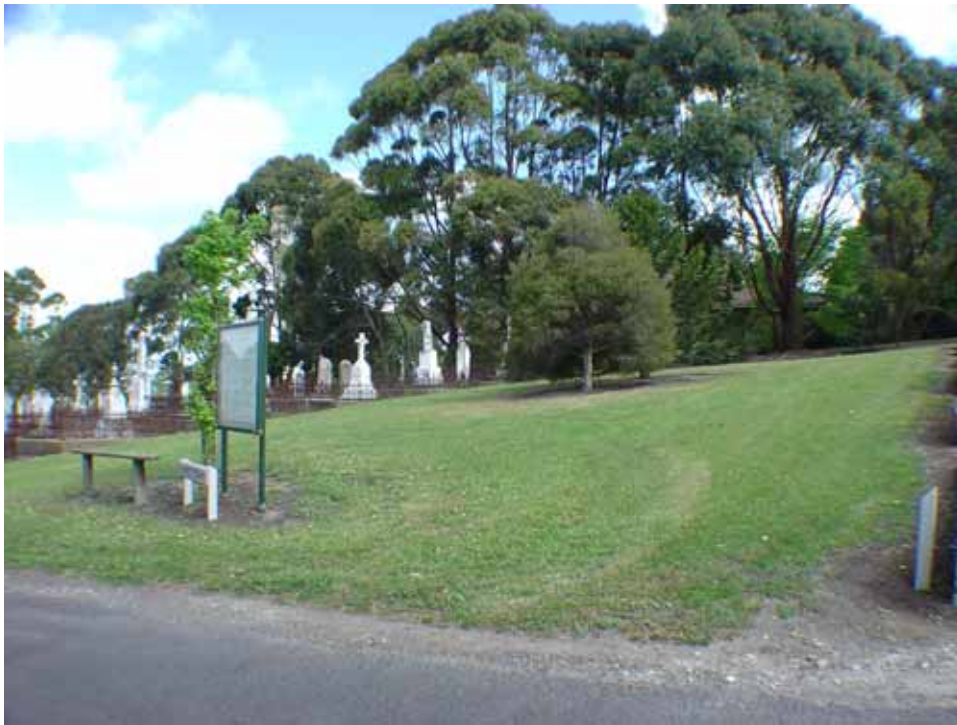
Site for Children's Memorial

- This should be sited at the top of the main drive, recognising the importance of this memorial within the community and the cemetery. The location in the ceremonial drive between Sections H and I is fitting, but also slightly concealed by the new Funeral Pine/Cypress to give the quiet and reflective quality of the space that is required.
- The physical structure should reflect the existing graves in each adjoining section, but be treated in a contemporary manner. The site will be enclosed by a low limestone wall on the uphill side, on which plaques can be attached, and on the lower side a new artist designed metal fence reflecting the old cast and wrought iron fencing. Within the space a monument could be placed with some sort of sculptural element, even an 'angel' to complement the neighbouring sections. Seats should be provided for quiet solitude and rest while at the memorial.
